**Flood Control Project Maintenance
Levee Inspections**

Maintenance Issue Types Only, Levee Inspection Report By Mile - Spring 2015

Sutter Maintenance Yard Maintenance Area 0003

Waterway	Bank	Unit Miles	Inspection Start/End	Inspector
Unit No. 01 Feather River	Right	5.11	04/17/2015 04/17/2015	Michael Pitta

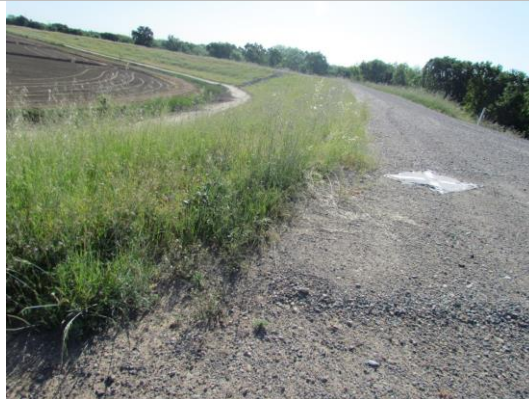
Photo 1 of 1 : SP_2015_MA0003_195_8_20150421_00011.jpg

LM Start	0.01	Rating **	M	Issue No.	8
LM End	5.10	Issue Type +	Ma	Location *	LS
Category	Earthen Levee			GPS Latitude/Longitude	
				Start	End
Item	Vegetation			38.898032 °	°
				-121.617923 °	°
DWR ID	DWR_MA0003_01_s_2015_8				
Action/Comments					
Control annual grass and weeds on the levee slopes and easements.

Photo of vegetation taken looking upstream at the landside of the levee.

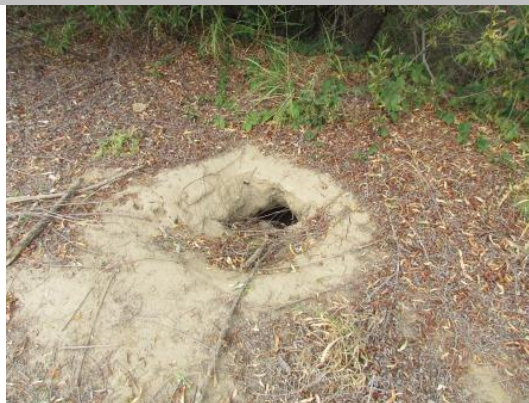
Photo 1 of 2 : SP_2015_MA0003_195_140_20150401_00008.jpg

LM Start	0.78	Rating **	U	Issue No.	140
LM End	0.78	Issue Type +	Ma	Location *	N/A
Category	Earthen Levee			GPS Latitude/Longitude	
				Start	End
Item	Crown Surface / Depressions / Rutting			38.903339 °	38.903339 °
				-121.606209 °	-121.606209 °
DWR ID	DWR_MA0003_01_f_2014_140				
Action/Comments					
Repair depressions or ruts in the crown or slope. Inspector Comments: There is a sinkhole on the landward toe road approximately 12" in diameter leading to the adjacent drainage ditch.

This photo was taken from the landward levee slope near the toe road facing north looking at an approximately 12" sink hole going from the toe road to the adjacent drainage ditch that parallels the toe road. Fall 2014.

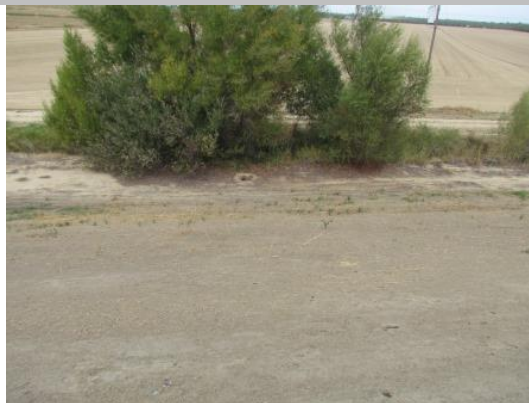
Photo 2 of 2 : SP_2015_MA0003_195_140_20150401_00009.jpg

This is another photo of the sink hole to show its relationship to to levee toe, toe road, and drainage ditch. Fall 2014.

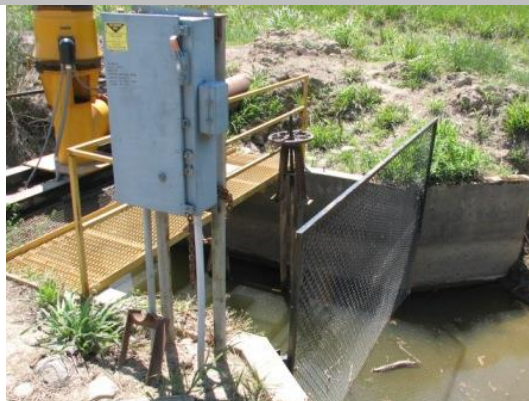
Photo 1 of 1 : SP_2015_MA0003_195_5_20150401_00001.jpg

LM Start	0.80	Rating **	M	Issue No.	5
LM End	0.80	Issue Type +	Ma	Location *	LS
Category	Interior Drainage & Piping Systems			GPS Latitude/Longitude	
				Start	End
Item	Sluice / Slide Gates			38.903291 °	38.903291 °
				-121.605747 °	-121.605747 °
DWR ID	DWR_MA0003_01_s _ 2012_5				
Action/Comments					
Inspector Comments: This pipe leaked during the high water event of 2010/2011.

Levee mile 0.80, this photo is looking at the landside toe, one of these pipes leaked during the high water event of 2010/2011. A flap gate prevents flow from the waterward side to the landward side of the levee.

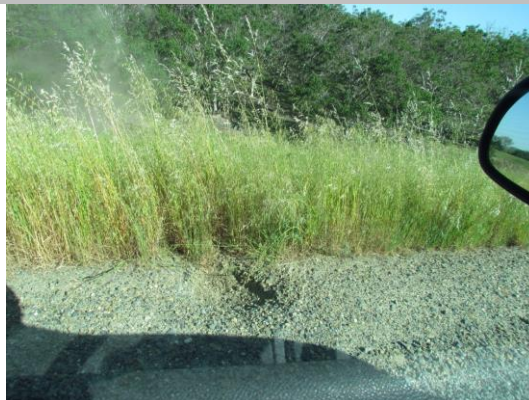
Photo 1 of 1 : SP_2015_MA0003_195_13_20150421_00012.jpg

LM Start	1.51	Rating **	M	Issue No.	13
LM End	1.51	Issue Type +	Ma	Location *	CR
Category	Earthen Levee			GPS Latitude/Longitude	
				Start	End
Item	Crown Surface / Depressions / Rutting			38.904680 °	38.904680 °
				-121.594229 °	-121.594229 °
DWR ID	DWR_MA0003_01_s _ 2015_13				
Action/Comments					
Repair depressions or ruts in the crown or slope.

Photo of a depression in the crown, taken looking at the landside.

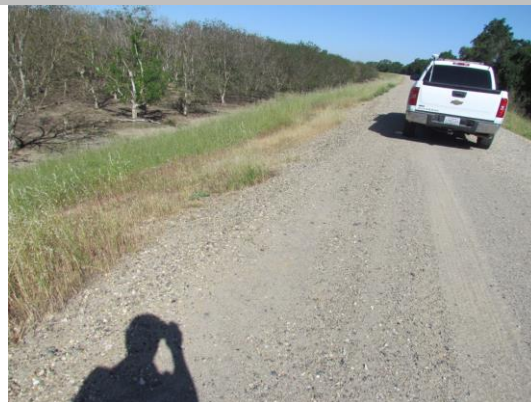
Photo 1 of 1 : SP_2015_MA0003_195_20_20150421_00013.jpg

LM Start	3.20	Rating **	M	Issue No.	20
LM End	3.20	Issue Type +	Ma	Location *	LS
Category	Earthen Levee			GPS Latitude/Longitude	
				Start	End
Item	Slope Stability			38.925909 °	38.925909 °
				-121.585401 °	-121.585401 °
DWR ID	DWR_MA0003_01_s _ 2015_20				
Action/Comments					
Repair slope instability.

Photo of slope on the landside facing upstream, areas with little vegetation appear to have eroded leaving the crown smaller.

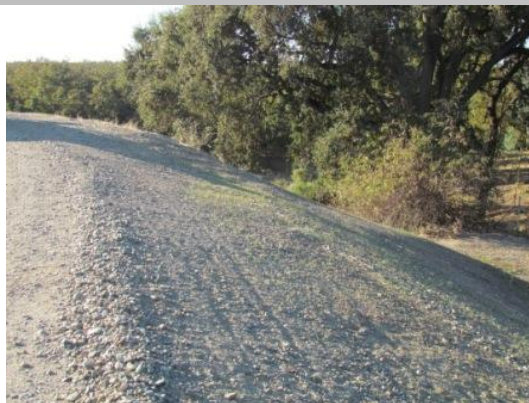
Photo 1 of 1 : SP_2015_MA0003_195_19_20150401_00007.jpg

LM Start	3.59	Rating **	M	Issue No.	19
LM End	3.59	Issue Type +	Ma	Location *	LS
Category	Earthen Levee			GPS Latitude/Longitude	
				Start	End
Item	Vegetation			38.930063 °	38.930063 °
				-121.590211 °	-121.590211 °
DWR ID	DWR_MA0003_01_f_2013_19				
Action/Comments					
Elderberries are blocking visibility and flood fight capability. Inspector Comments: Elderberries on the landward levee toe.

This photo was taken from the levee crown facing south looking down the landward levee slope at a group of Elderberries. Fall 2013.

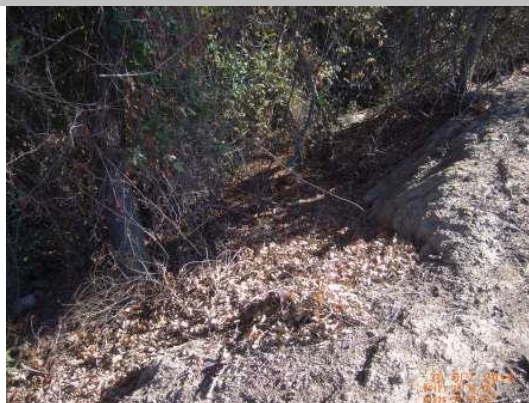
LM Start	4.15	Rating **	M	Issue No.	10
LM End	4.18	Issue Type +	Ma	Location *	WS
Category	Supplemental			GPS Latitude/Longitude	
				Start	End
Item	USACE Erosion Survey			38.937454 °	38.937937 °
				-121.588544 °	-121.588471 °
DWR ID	DWR_MA0003_01_f_2014_10				
Action/Comments					
Inspector Comments: 2013: Minor toe scour causing gradual erosion of bank slope. Site is within ecological reserve. [2013 Site ID: FHR_12-3_R]

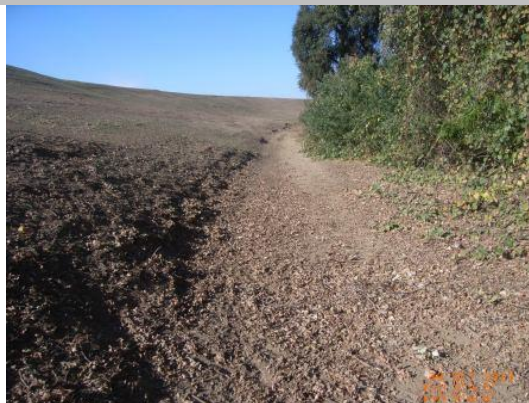
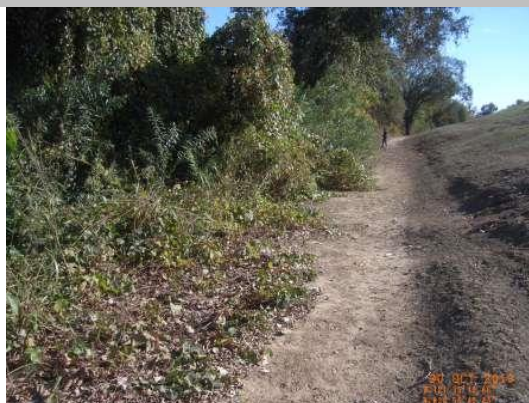
LM Start	4.71	Rating **	M	Issue No.	11
LM End	4.76	Issue Type +	Ma	Location *	WS
Category	Supplemental			GPS Latitude/Longitude	
				Start	End
Item	USACE Erosion Survey			38.945190 °	38.945967 °
				-121.586073 °	-121.586328 °
DWR ID	DWR_MA0003_01_f_2014_11				
Action/Comments					
Inspector Comments: 2013: Minor toe scour causing gradual erosion into the bank slope [2013 Site ID: FHR_12-8_R]
